Historic Heard County Jail Refurbishment

Subject: Heard County Historic Jail Brick Crack Assessment – Court Square, Franklin, Georgia

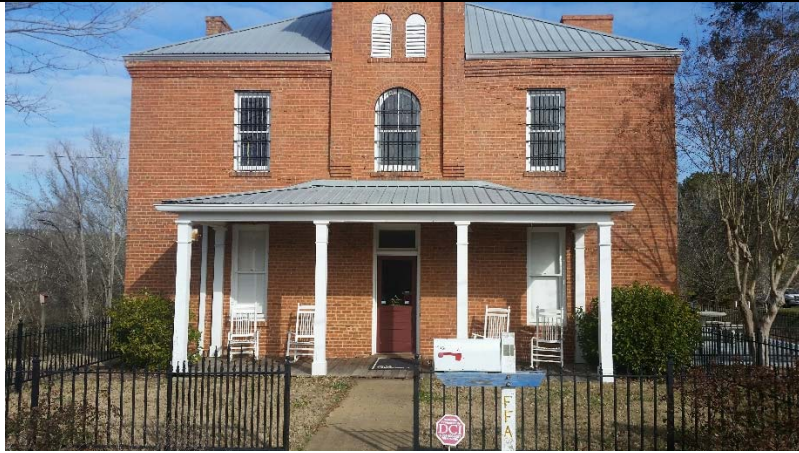
1. Overall view of the front of the existing Jail.

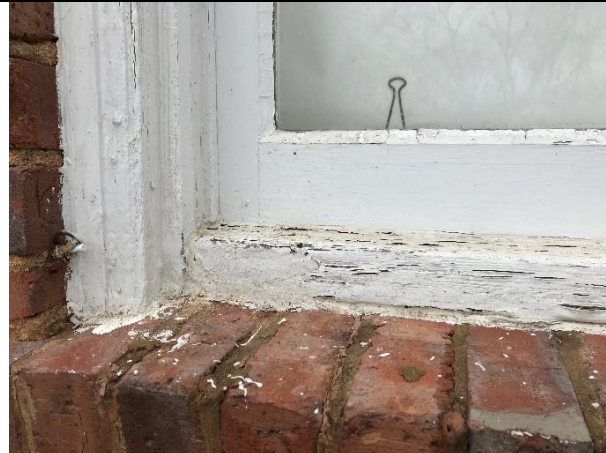
2. Typical rotted and damaged wood windows throughout the Jail.

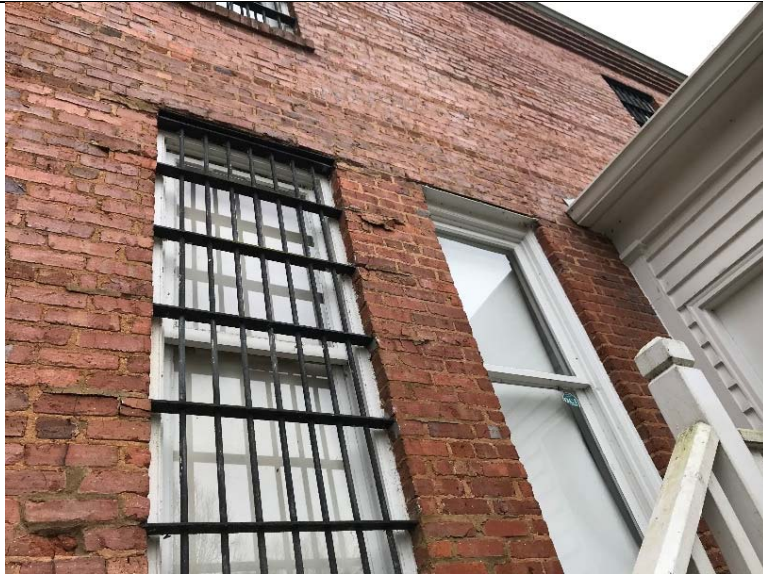
3. Steel security bars that are spalling the face of the brick off at the connection points.

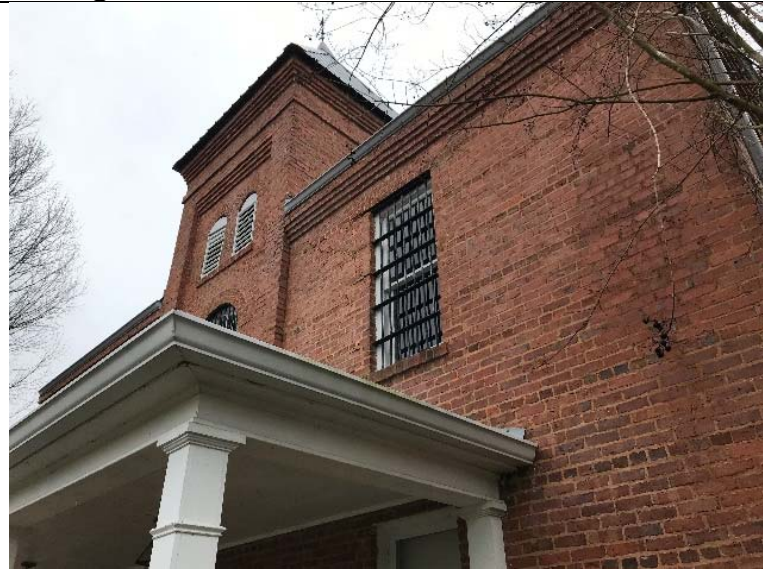
4. Steel security bars that are spalling the face of the brick off at the connection points. And large crack at corner.

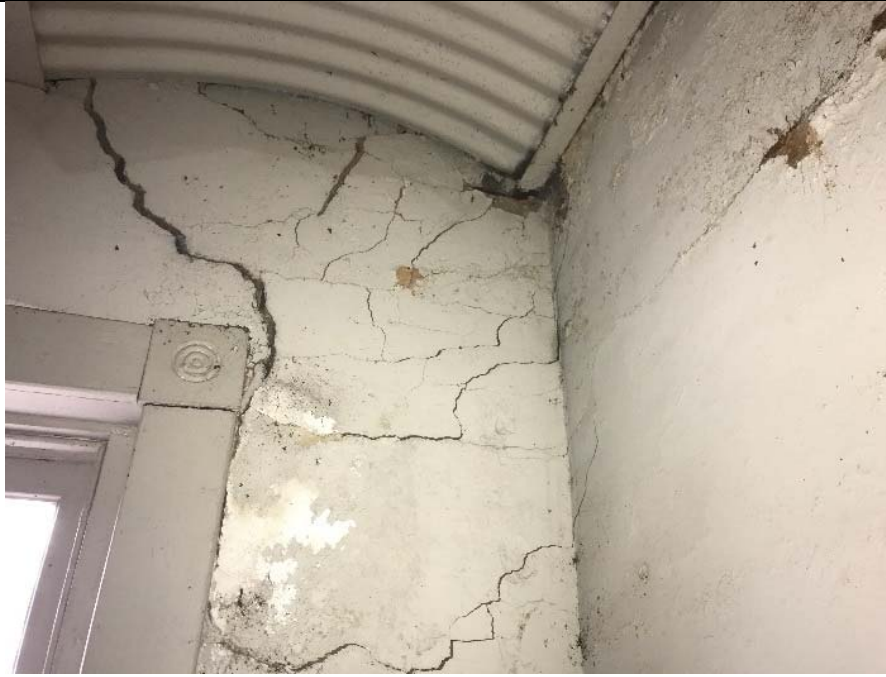
5. The exterior crack in picture #4 is starting to extend through the brick mass wall to the inside.

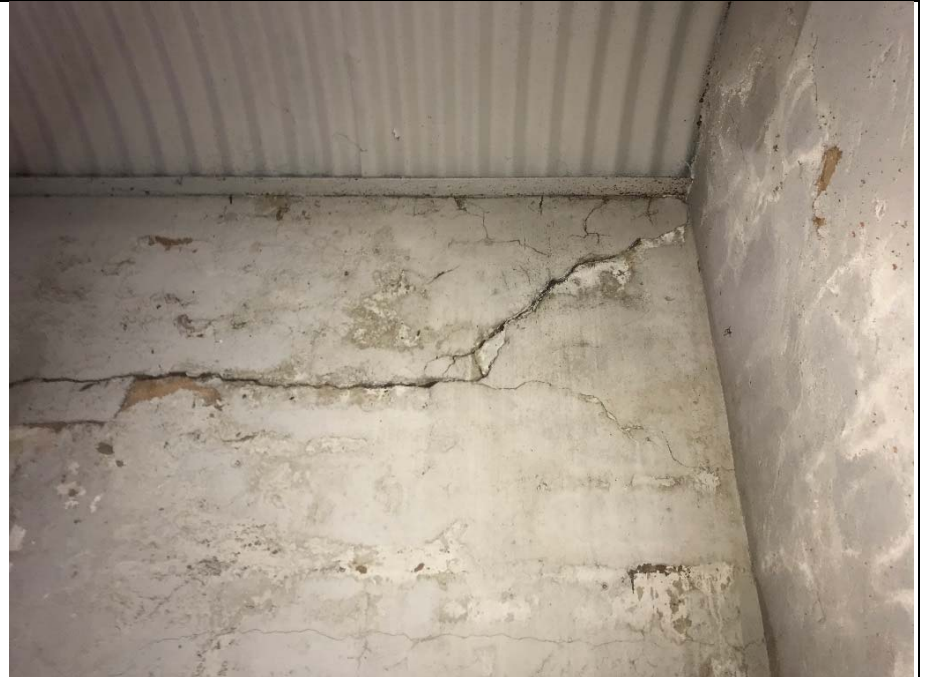
6. The exterior crack in picture #4 is starting to extend through the brick mass wall to the inside.

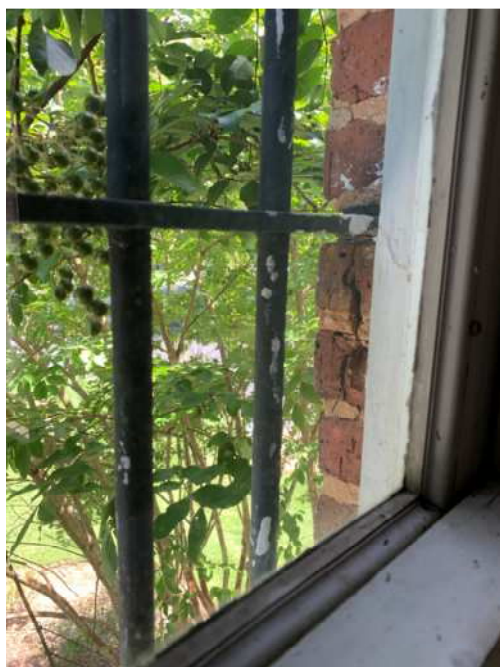
Photo 2

The building is a two story structure with a crawl space and is currently being used as a historic jail museum. The roof is a wood framed gable roof over a concrete ceiling above the second floor. The second floor is a concrete slab. The first floor is wood framed over the crawl space. The exterior walls are load-bearing triple wythe brick walls supported by a large stone foundation wall. The windows are covered on the exterior with a steel bar frame that is embedded into the exterior wythe of brick. Photo 1 is a picture of the southeast corner of the building. Photos 2 and 3 show the steel bar frames that cover the windows embedded in the brick.

It appears that the majority of the cracking in the brick walls is most likely caused by water infiltration and subsequent rusting of the steel bars embedded in the brick. As the steel bars rust, they expand and push on the brick around them, causing separations and cracks in the brick. Photos 2, 3, 4 and 5 show some of the cracks and displacement of the brick around the locations where the steel bar frames are embedded in the brick.

After a visual review of the building, GGHE recommends removing all of the embedded steel bar frames from the windows to stop any further deterioration of the brick walls. After the steel bar frames are removed, the brick and mortar should be repaired. The damaged brick and mortar on the top of the southeast corner should be repaired/replaced as needed to get the brick wall back to its original position and bring the wall back to its original load carrying capacity. Prior to starting work on the southeast corner, the second floor slab, second floor ceiling and roof should be shored to grade. The remaining smaller cracks throughout the remainder of the walls should be repaired by replacing any cracked/missing mortar and replacing any broken bricks.

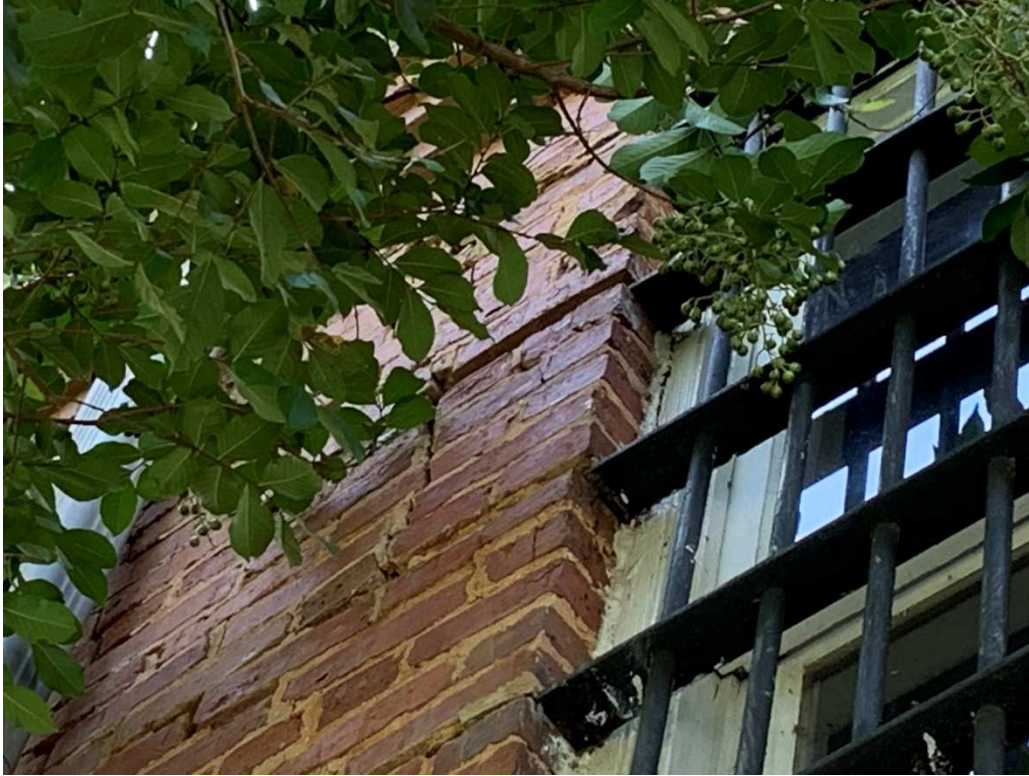
The southeast corner of the building has the worst displacement and cracks. The displacement and cracks in the brick wall can be seen on both the exterior and interior of the wall at this corner of the building. This corner differs from other areas of the building because there is a window opening approximately 36 inches from the corner. The distance from the other openings to the nearest corner of the building is at least double that dimension. It is likely that because the distance from the window to the corner is smaller here, there is less brick to resist the push from the rusting steel window bars. Because of the displacement and cracks at this corner, the structural capacity of the brick wall is compromised at this localized area of the wall.

GGHE does not know the extent of the structural degradation at this corner or any other location of the building. A more extensive investigation would be required to assess the structural capacity and stability of the building structure. Photo 5 and 6 show some of the displacement and cracks that have occurred at the southeast corner of the building.
